SHOHOLA MARSH DAM

PHASE I INSPECTION REPORT
NATIONAL DAM INSPECTION PROGRAM

NDI-PA 00412
PA DER 52-158

FEBRUARY 1979

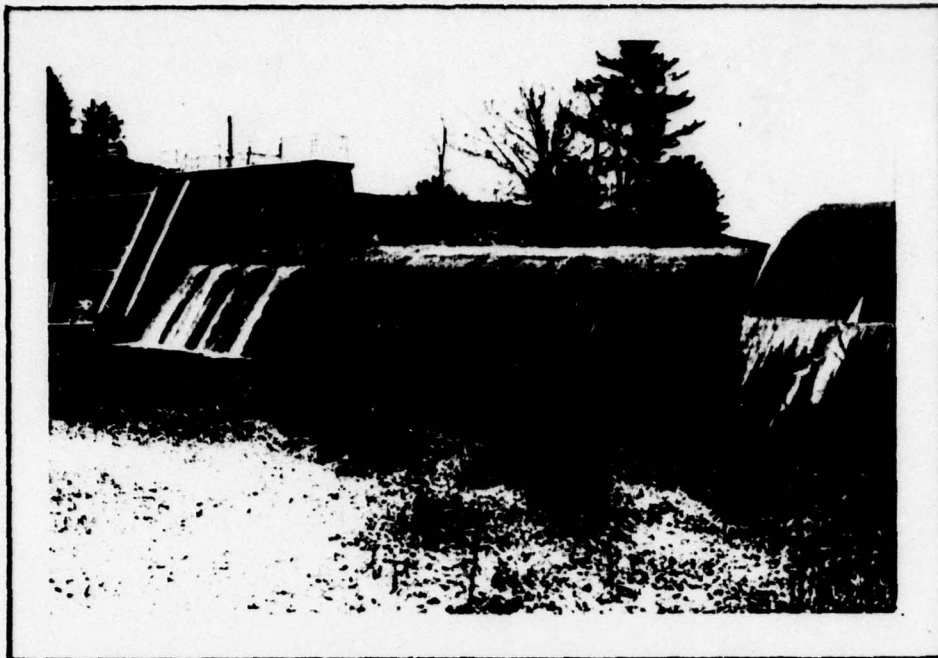
*SERVICE SPILLWAY WITH STOPLOG
CONTROLLED PORTION TO THE LEFT*

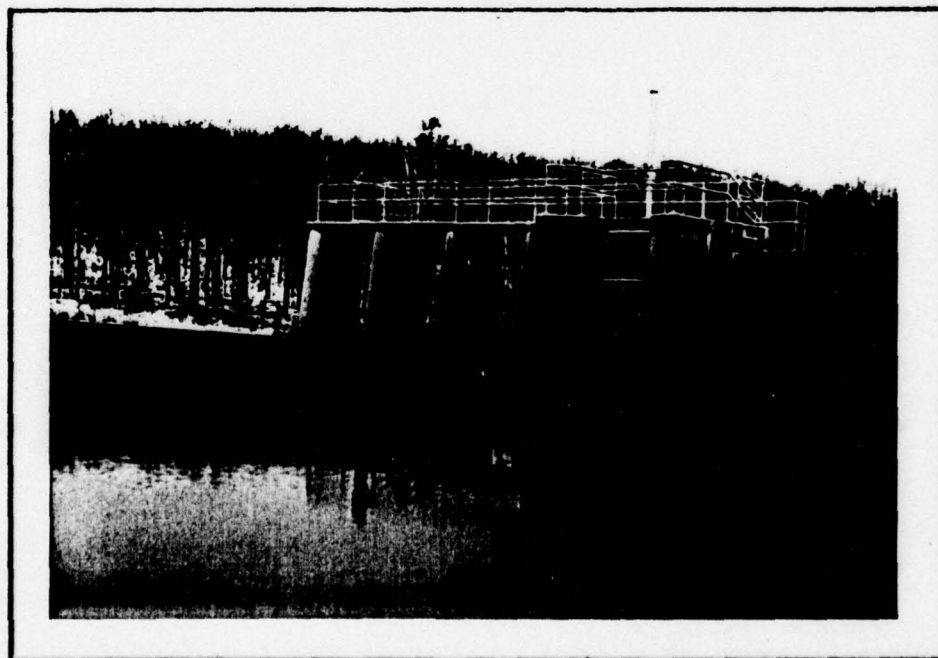
*UPSTREAM VIEW OF SERVICE
SPILLWAY AND OUTLET WORKS*

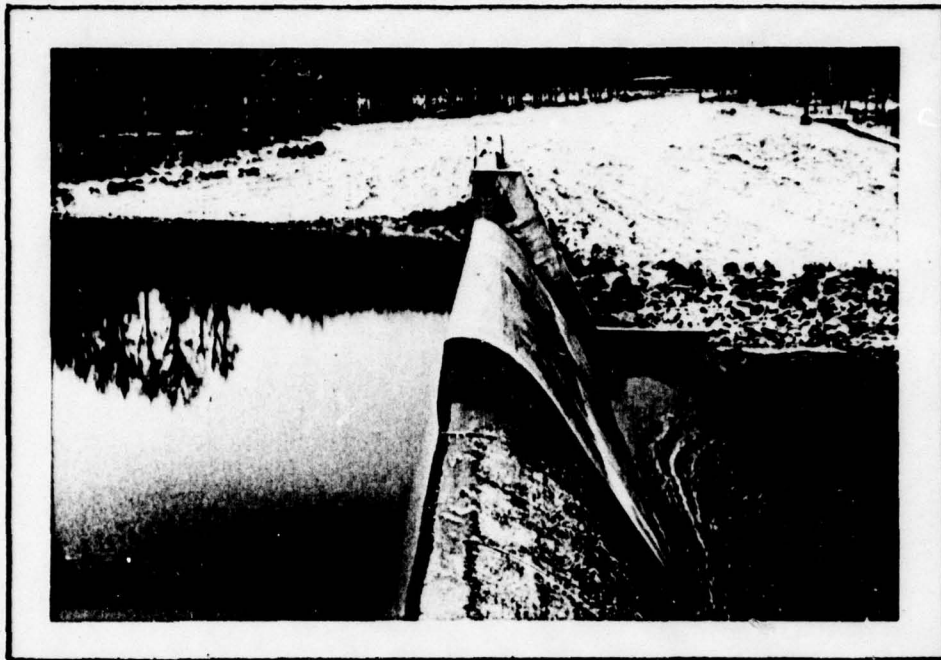
*SERVICE SPILLWAY AND LOWER EMERGENCY
SPILLWAY LOOKING TOWARDS LEFT ABUTMENT*

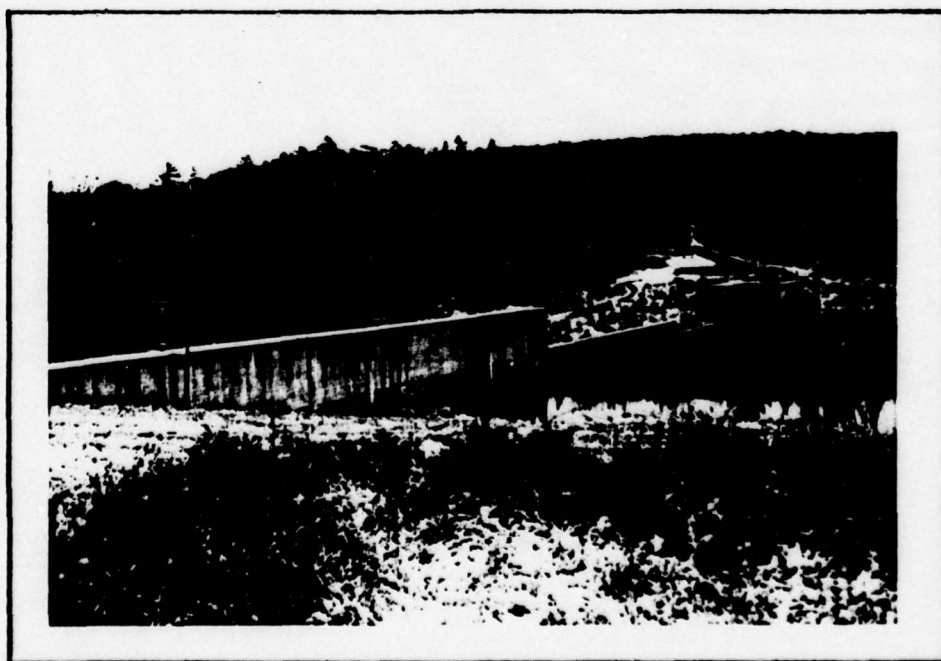
UPSTREAM VIEW OF DAM

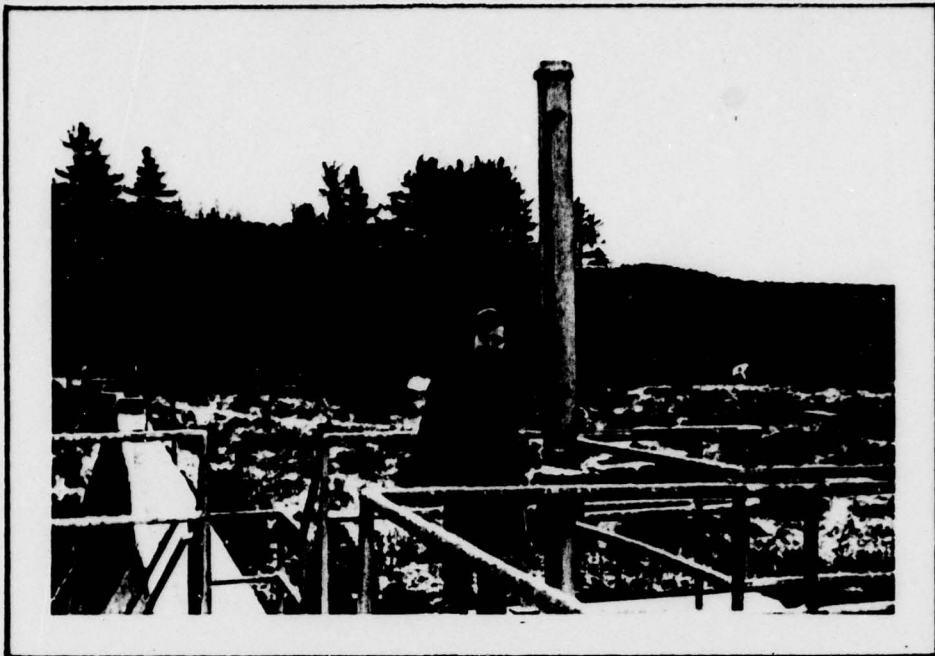
*ON SERVICE BRIDGE SHOWING
RESERVOIR DRAIN HOIST AND STEM*

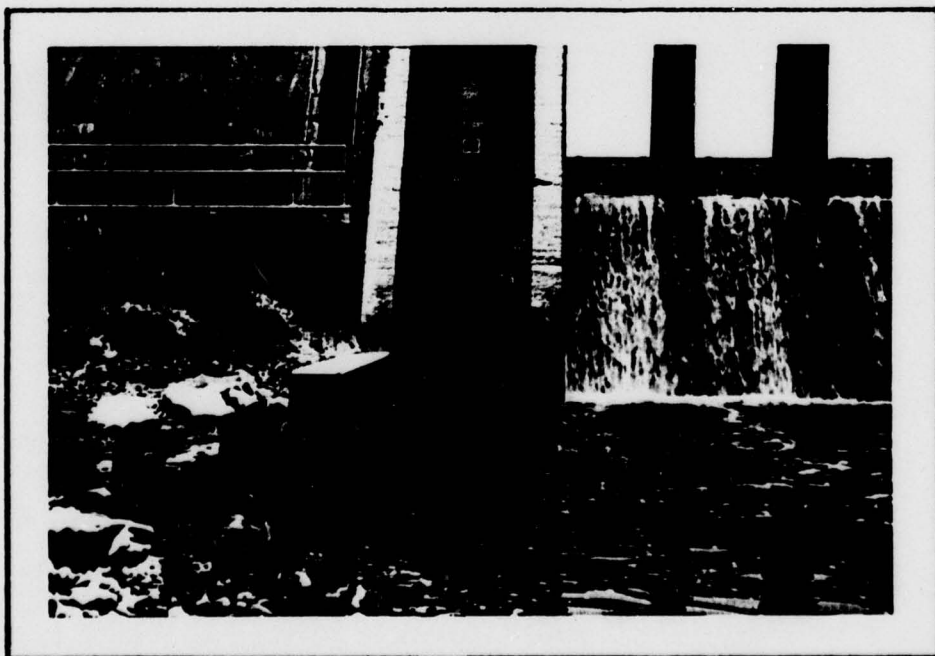
*RESERVOIR DRAIN AND STOP LOGGED
PORTION OF SERVICE SPILLWAY*

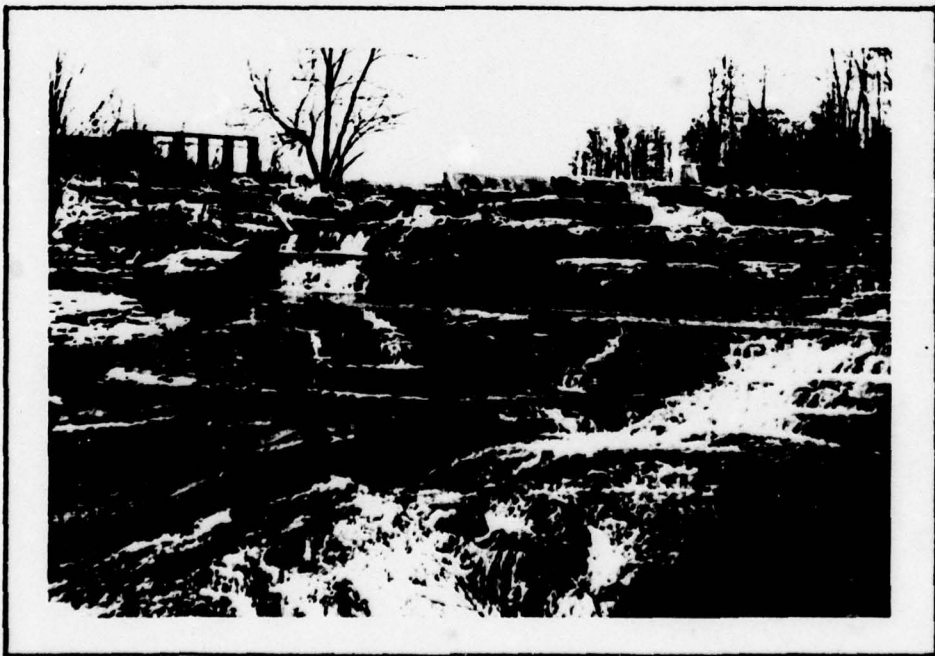
*FALLS OF SHOHOLA CREEK ABOUT 100 YARDS
DOWNSTREAM OF THE DAM*

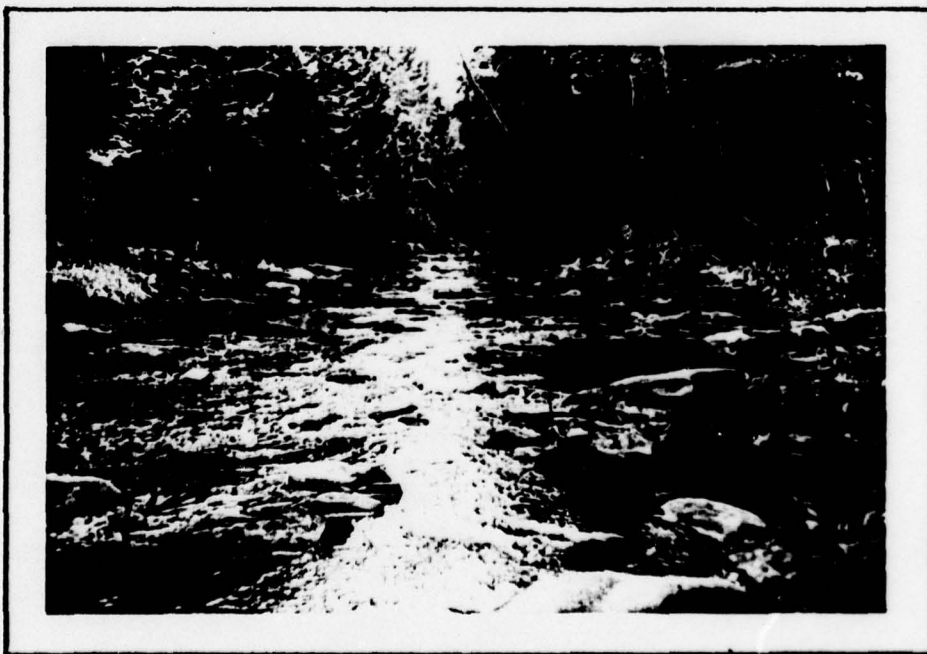
CHANNEL 3 MILES DOWNSTREAM OF DAM
